## PHOTOGRAPHIC EVALUATION REPORT

Mission 9040  
28, 29, 30, 31 July ZFE No. 33-62

<u>PAGE</u>
PART I	FORWARD CAMERA	<u>1-5</u>
PART II	AFT CAMERA	6-10
PART III	FRAMING CAMERA	11-12
PART IV	VEHICLE ATTITUDE DATA	13
PART V	DENSITY CHART	14

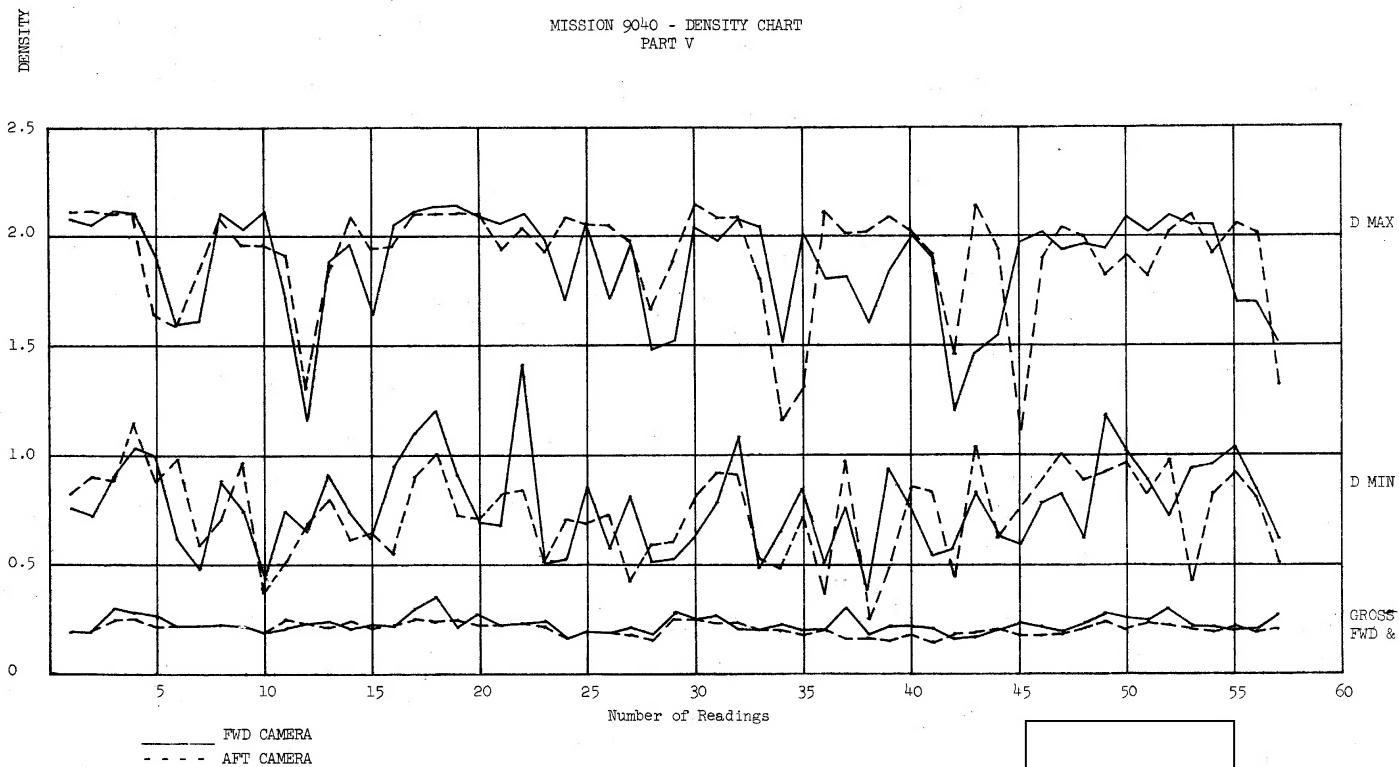
MISSION 9040 - DENSITY CHART  
PART V

8. Density readings were made on every pass using the MacBeth Quantalog Densitometer Model EP 1000 with an EP 20 attachment. Absolute values read for D Max and D Min as well as Gross Fog are given below. Uniform Gross Fog readings and static D Max columns have been added to this report in order that degradations of film due to those factors may be made available for further study.
